**RAILWAY INVESTIGATION REPORT
R02M0007**

YARD DERAILMENT

**CANADIAN NATIONAL
0700 YARD ASSIGNMENT
MILE 12.15, DARTMOUTH SUBDIVISION
DARTMOUTH, NOVA SCOTIA
15 FEBRUARY 2002**

Report Number R02M0007

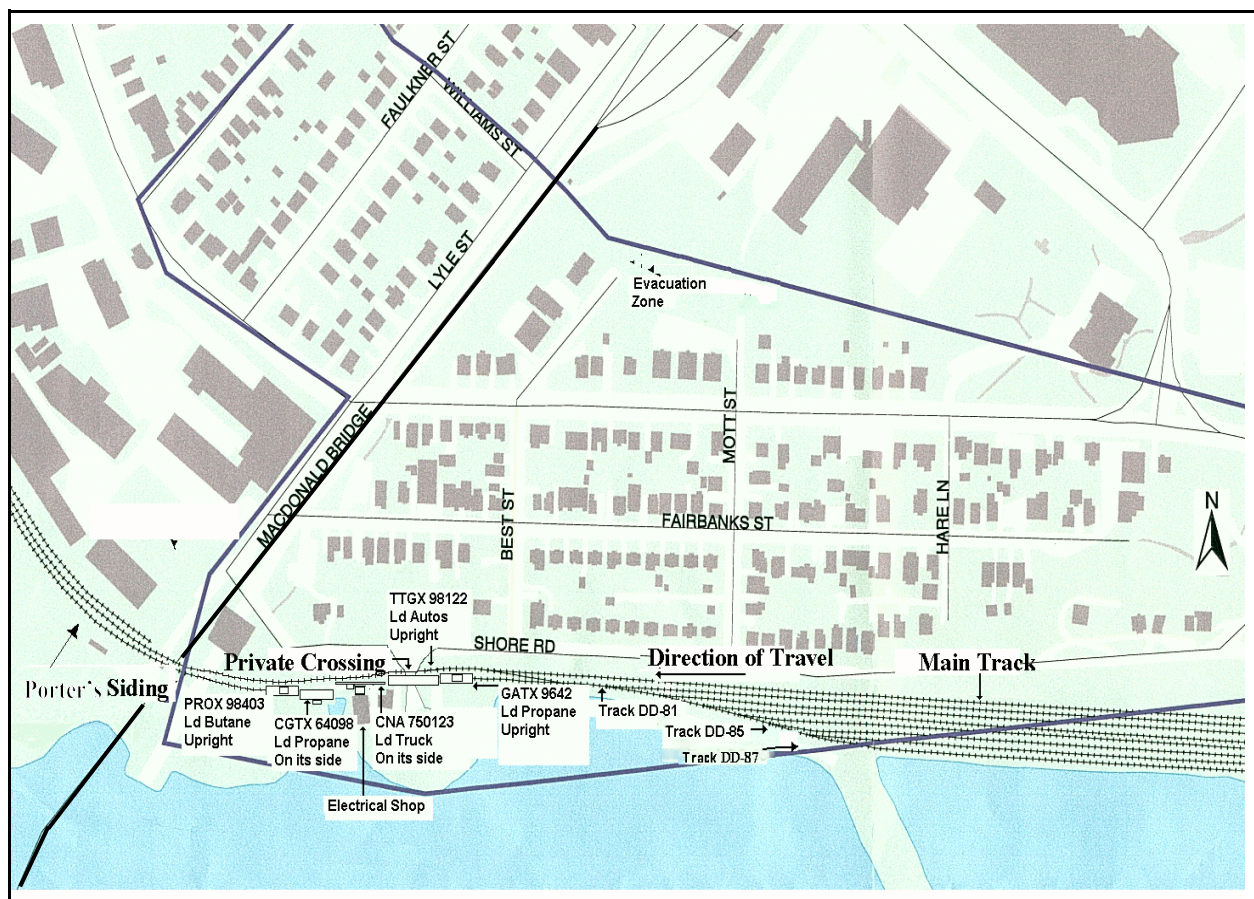
On 15 February 2002, at approximately 0955 Atlantic standard time¹, Canadian National (CN) 0700 yard assignment was coming to a controlled stop after pulling 15 cars in a westward direction when a train-initiated emergency brake application occurred. A subsequent inspection by the three crew members revealed that tank car PROX 98403 (a load of butane that was coupled to the locomotive) was derailed but upright; the following tank car, CGTX 64098 (a load of propane) was on its side toward the harbour edge; flat car CNA 750123 (loaded with a truck) was on its side nearly hitting an electrical shop south of the yard track; flat car TTGX 98122 (loaded with automobiles) was derailed but upright blocking a private crossing; and, tank car GATX 9642 (a load of propane) was derailed but upright on the east side of the private crossing (see Figure 2).

Figure 2. Schematic of derailment area including Porter's Siding, derailed cars, electrical shop, private crossing and evacuation zone; note Angus L. MacDonal Bridge at lower left corner

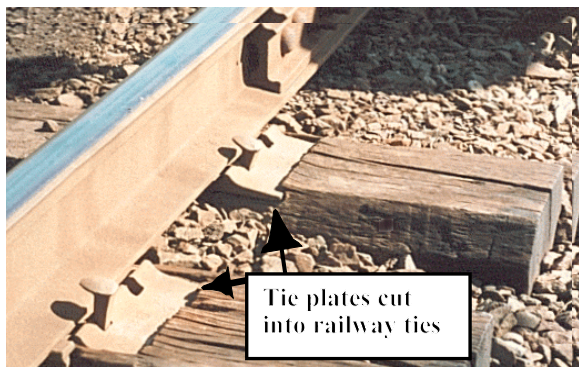
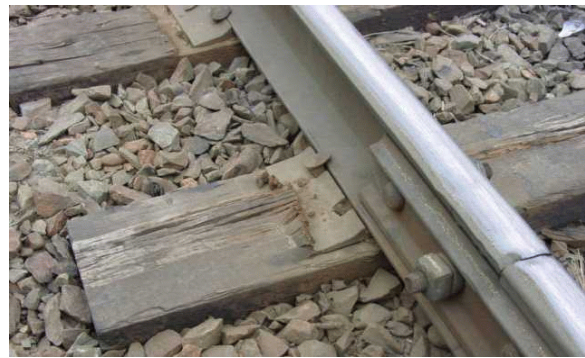
The first derailed wheel marks were noted on the base of the south rail at Mile 12.15, east of the private crossing. Between the yard lead and the private crossing, a distance of approximately 250 feet, a cluster of deteriorated ties was noted. The ties had differential plate-cutting² allowing lateral movement of the base of the rail, and loose track spikes were common (see Photos 1 and 2). Measurements of track gauge, elevation and rail wear, recorded in stations located approximately 19 feet 6 inches apart, were obtained from a main track crossover switch up to the location of the first derailed wheel mark and are shown in Appendix A. The maximum track gauge as measured under static conditions was 58 ¼ inches located in the area of the first derailed wheel mark. TC's TSR allow a maximum of 1 ¼ inches wide gauge from a nominal track gauge of 56 ½ inches (i.e. 57 ¾ inches maximum) for Class 2 track.

Photos 1 and 2. Track conditions near the initial point of derailment, including plate-cut ties and spikes.

A condition caused by extensive wear between the metal base of a tie plate and a wooden tie, resulting in the surface of the tie being cut in depth and width with resulting loss of gauge restraint.

1. The yard movement derailed as a result of excessive track gauge due to deteriorated tie conditions.
2. Because of its mechanical condition, the loaded tank car of propane induced higher than normal lateral loads, resulting in further dynamic gauge-widening, beyond acceptable limits of safety.

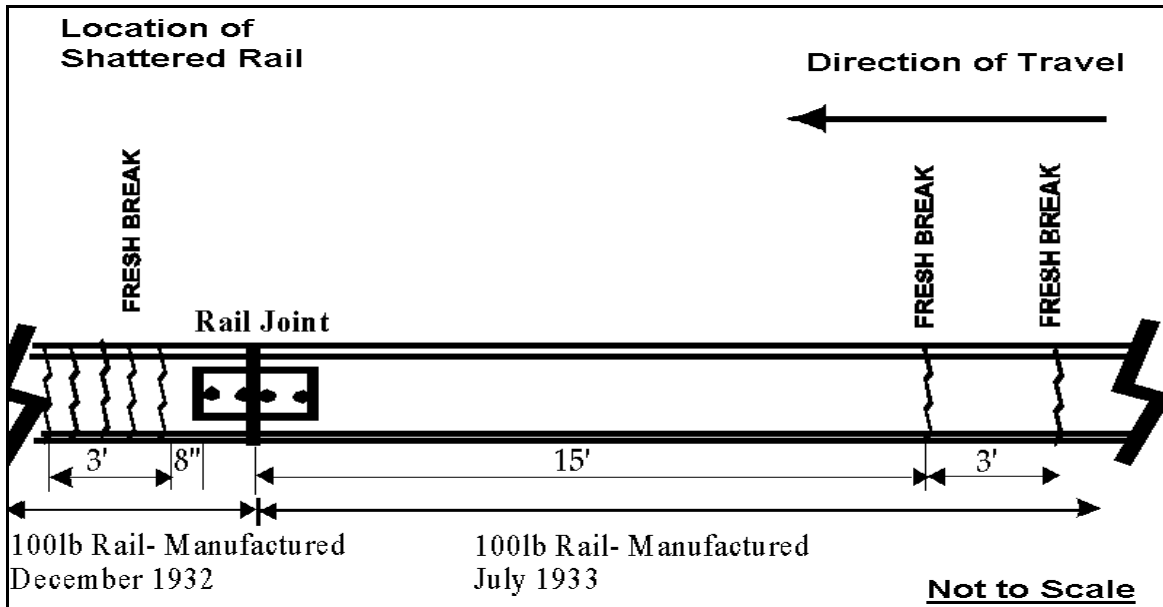
The south rail had multiple fractures at three locations within the private crossing. The fractures were located on two adjacent rails that were joined together with a four-bolt rail joint bar (see Figure 3). The rail on the west side of the rail joint had shattered into eight pieces. The west rail length was manufactured in December 1932; the other in July 1933; both by Dominion Steel. They were laid in 1953.

Figure 3. Layout of rail fractures on south rail within private crossing

The TSB Engineering Laboratory examined twelve pieces of rail taken from the two rail sections (Report LP 11/02). The examination revealed the following:

- No signs of pre-cracking or pre-existing failures were observed.
- The fractures observed on the pieces of rail submitted were all considered to have occurred as a result of overstress failure.
- The overstress was likely induced by the gauge of the rails spreading, allowing the wheels to travel between the rails and generating an excessive lateral load on the rail.
- No material deficiencies were observed which could have been a contributory factor in the failure.

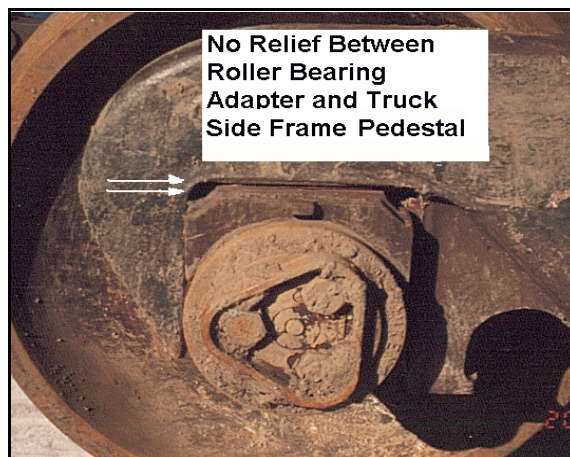
CGTX 64098, the second derailed car, was a specification DOT 112J340W pressure tank car with a load limit of 158 900 pounds, built in September 1970. The car was equipped with Barber S-2 trucks, with 36-inch diameter wheels and 6½ X 12-inch roller bearings. The trucks were furnished with D-3 springs, which have a spring travel of 2½ inches and provide a somewhat stiffer ride than cars with longer travel springs (e.g. D-5 springs with 3¾ inches of spring travel). There were bright marks on the rim of the centre plate bowl on the leading truck, where the top portion was in contact with the body centre plate casting. These marks were not due to the short distance that the car travelled derailed. Association of American Railroads (AAR) standards require cars to have a minimum of 1/16 inch clearance in this area. There was no visible relief between the roller bearing adapters and the ceiling of the truck side frame pedestals on the lead truck, and at one location on the trailing truck (see Photo 3) due to wear on the roller bearing adapter or truck side frame. The car last received a safety inspection by a certified car inspector on 12 February 2002 when the car was on train CN 454 at Moncton, New Brunswick. No defects were identified at that time.

Photo 3. Lack of adapter relief on CGTX 64098; also note marks on wheel plate due to contact with non-ferrous materials (e.g. ballast and ties).

The worn conditions of the centre plate and roller bearing adapters on tank car CGTX 64098 would tend to affect rotational movement of the car in two ways: by inhibiting the lateral movement of the wheels within the lead truck and the rotational movement of the lead truck relative to the car body. Because the car was loaded, it was transmitting relatively high vertical loads to the truck centre plates, and ultimately to the axles through the truck sides. Loaded cars with stiff, and short, suspension systems subject both the car and the rail to increased loads when encountering deficiencies in the track infrastructure. Since rotational movement is initiated by wheel flange contact with a curved rail, and the worst wide gauge conditions existed at the curved portion of Porter's Siding, the stiffer than normal rotational movement of the tank car exacerbated the wide gauge conditions. Because the loaded tank car of propane had insufficient clearance at the centre plate area, higher than normal lateral loads were induced onto the track. The weak track structure did not provide sufficient lateral resistance resulting in further dynamic gauge-widening, beyond safety limits.
